Simmons Home Inspections, LLC

Inspection Report

Date: 7/4/2017	Time: 08:00 AM	Report ID: 400
Property:	Customer: John Doe	Real Estate Professional:

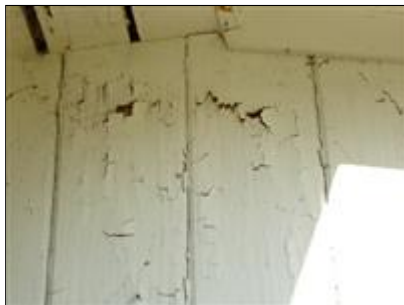
1.1 Picture 1

1.1 (1) The paint is peeling and the home needs to be prepped, primed and painted.

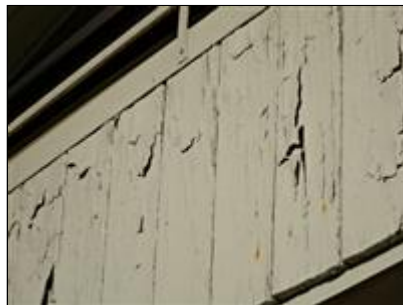
1.1 Picture 2

(1) The paint is peeling and the home needs to be prepped, primed and painted.

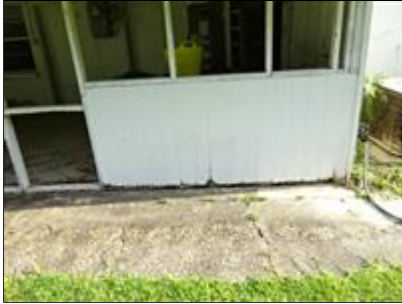
1.1 Picture 4

(2) Moisture damage at multiple areas around the screened porch.

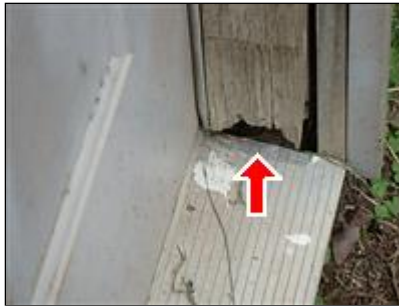
1.2 Picture 1

1.2 Moisture damage at the rear entrance door.

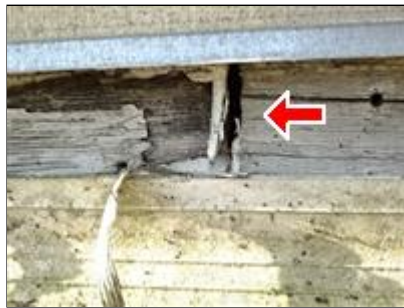
1.6 Picture 1

1.6 Moisture damage is occurring at multiple areas around the exterior.

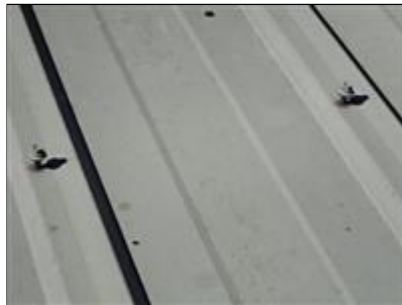
2.0 Picture 1

2.0 Many screws were found to be loose on the metal roof. This needs to be corrected to prevent leaks from occurring.

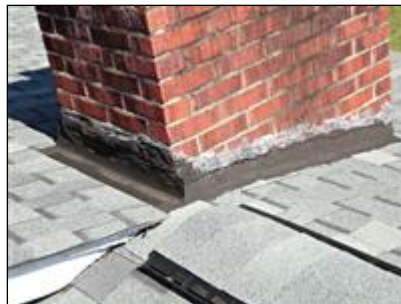
2.1 Picture 1

2.1 The chimney base has been tarred instead of flashed. This area will need periodical maintenance.

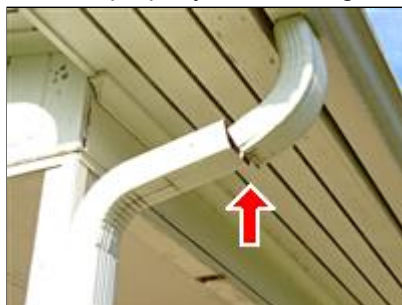
2.3 Picture 1

2.3 (1) Downspouts not connected properly and missing in areas.

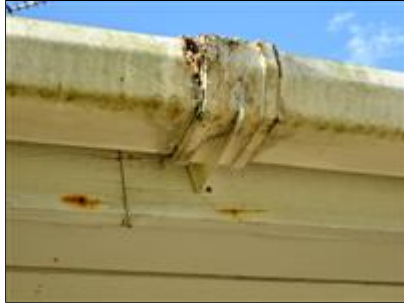
2.3 Picture 3

(2) The gutters are in poor condition and need cleaning of debris. Gutters that drain poorly or clogged can lead to many

costly problems such as deterioration of fascia,soffit or roof edge, the debris in gutters can also conceal damage, rust, deterioration or leaks that are not visible until cleaned.

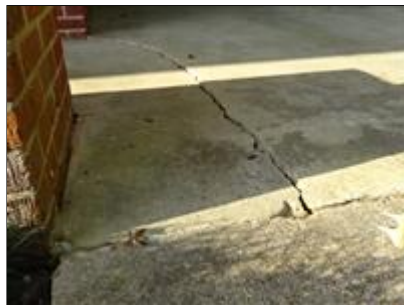
3.1 Picture 1

3.1 The carport slab is cracked and settled approximately 3-4 inches at the rear. I would recommend a qualified licensed contractor evaluate further and correct as needed.

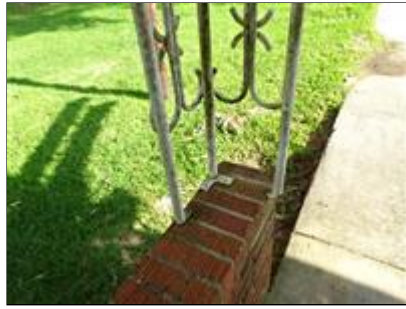
3.5 Picture 1

3.5 One or more metal support post are not secured properly.

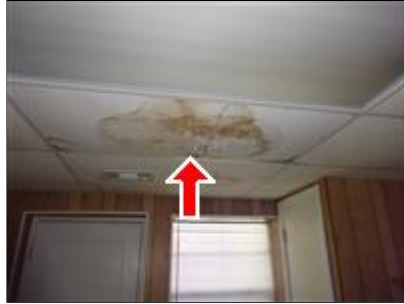
4.0 Picture 1

4.0 Moisture stains and elevated moisture indicating what appears to be a plumbing leak at the downstairs bedroom. Recommend a qualified licensed plumber and contractor correct as needed.

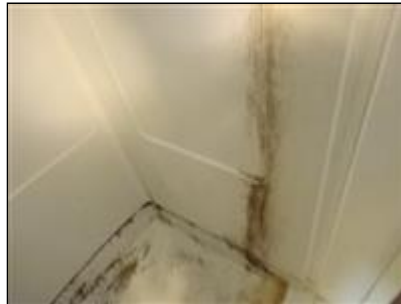
4.1 Picture 1

4.1 Signs of fungi growth is present at the downstairs bath. We did not inspect, test or determine if this growth is or is not a health hazard. It is beyond the scope of this inspection to identify what substance or organism this is. The underlying cause is moisture. I recommend you contact a mold inspector or expert for investigation or correction if needed.

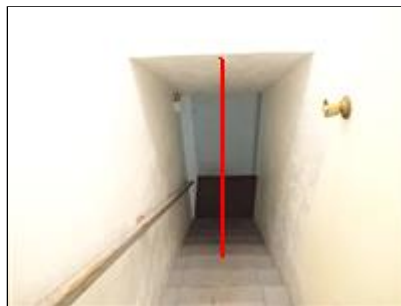
4.3 Picture 1

4.3 The ceiling height over the stairs was too low (75 inches) and poses a safety hazard, especially for tall people. Ceilings over stairs should be at least 6 feet 8 inches high. At a minimum, be aware of this hazard, especially when guests who are not familiar with the stairs are present.

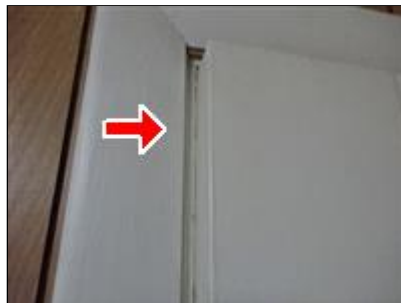
4.5 Picture 1

4.5 Several doors will not close throughout the home.

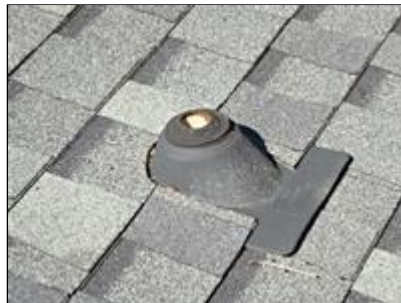
6.0 Picture 1

6.0 (1) The plumbing vent pipe should extend above the boot flange approximately 6 inches.

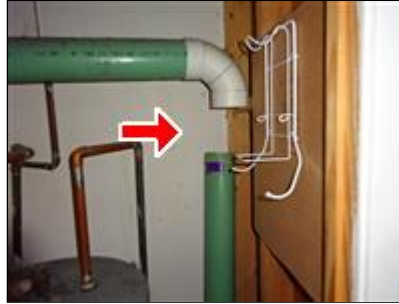
6.0 Picture 2

(2) Vent pipe is not connected at the downstairs closet.

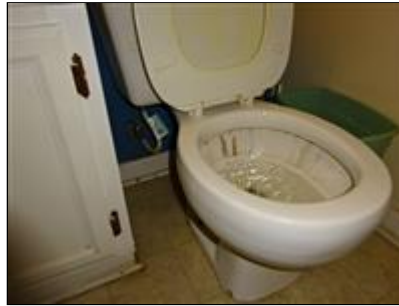
6.0 Picture 3

(3) The toilet in the downstairs bath is inoperable.

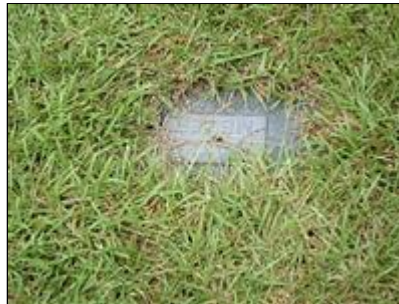
6.3 Picture 1

6.3 The main water shut off is located outside in the ground.

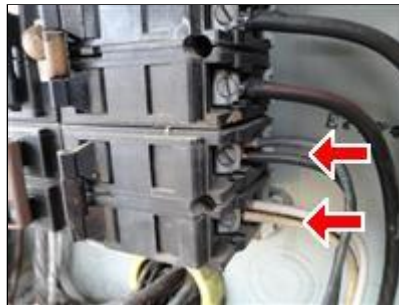
7.1 Picture 1

7.1 Double tapping at the exterior panel. Why it's a problem: If the circuit breaker isn't designed to hold two wires, the wires could come loose at some point in the future, even if they feel very tight today. Loose wires can lead to overheating, arcing, and possibly a fire.

7.7 Due to the dangers of electrical components, all defects, even ones listed as minor should be addressed and corrected by a qualified licensed electrician. Also, any other problems discovered by the electrician while performing repairs should be corrected as needed.

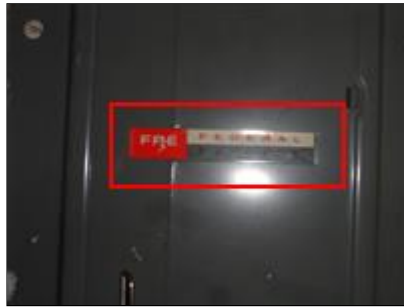
7.2 Picture 1

7.2 (1) You have a Federal Pacific panel and there is a possibility that the circuit breakers may not trip when shorted possibly causing an electrical hazard. Opinions by licensed electrical contractors on this panel varies between safe and unsafe. I recommend that a qualified licensed electrician evaluate the panel further and repair or replace as needed.

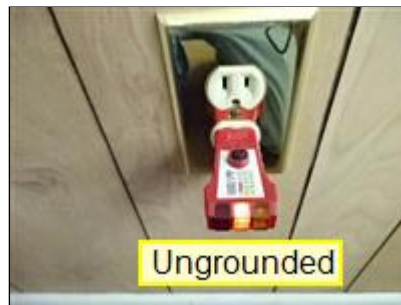
7.2 Picture 3

(2) "Common defect found in many older homes" The house has 3-prong receptacles and most all of them are ungrounded. The lack of a grounding conductor will limit the use of certain appliances that require a ground.. Although a ground isn't required of 2-prong receptacles, if the receptacle is 3-prong and ungrounded, it gives a false sense of safety. Grounding of all 3 prong receptacles or protection with ground fault circuit interrupters (GFCI's) is recommended for safety reasons.

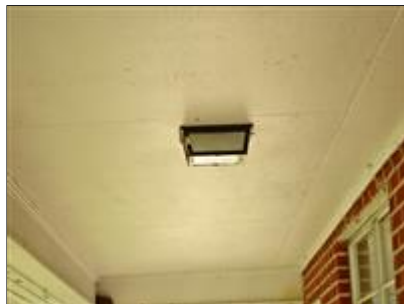
7.3 Picture 1

7.3 (1) Some light fixtures at the exterior of the home did not respond to the switch. The bulbs may be burned out or a problem may exist with the fixtures, wiring, or switches. If after the bulbs are replaced and these lights still fail to respond to the switch I recommend a licensed electrician evaluate further and repair or replace as necessary.

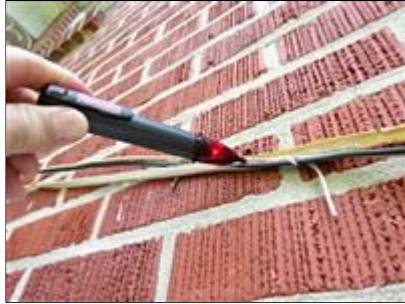
7.3 Picture 3

(2) Exposed, damaged wiring at the right side of the home and at the AC condenser. Today's common building standards

generally require electric wires to be protected, which typically (but not in all cases) means enclosed, or encased in conduit or a raceway, particularly if below seven feet or in an area where it can easily be damaged for safety.

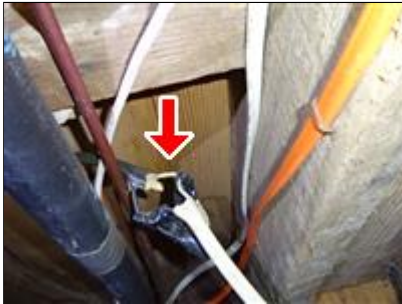
7.3 Picture 5 Storage room

(3) Hot, improper/open splices at the storage room and attic. All splices and loose wire ends should be installed inside a box with a cover plate to contain any sparks that could be created "if" there were ever a problem with the connections and to prevent electrical shock.

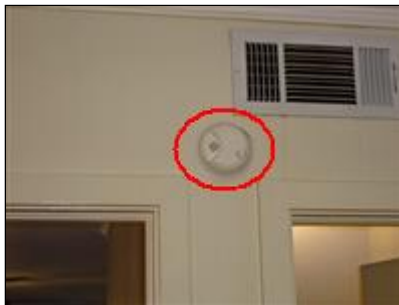
7.8 Picture 1

7.8 The smoke detectors were inoperable. It is recommended at least one smoke detector be located on each level of the home and all bedrooms should have one smoke detector installed for safety

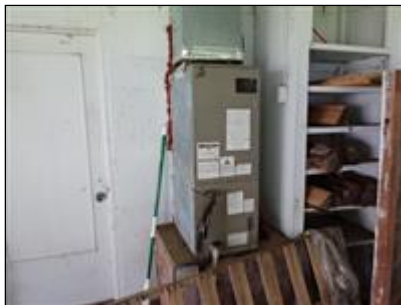
8.0 Picture 1

8.0 (1) The downstairs unit is over 20 years old and did not function at the time of the inspection. Recommend a qualified HVAC technician repair or replace as needed. A replacement is likely.

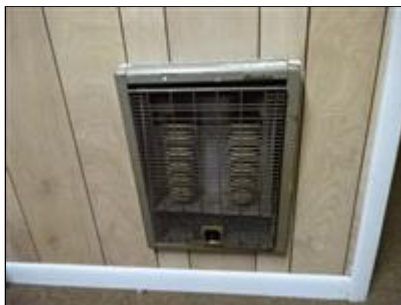
8.0 Picture 2

(2) The old wall heaters are inoperable.

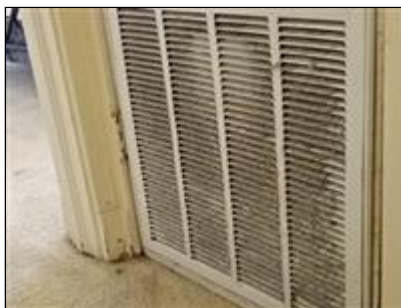
8.3 Picture 1

8.3 The disposable filter is dirty. As a result unfiltered air will flow through the system. Equipment life and the indoor air quality may be reduced. Recommend that filters be cleaned or changed once a month during the heating and cooling seasons.

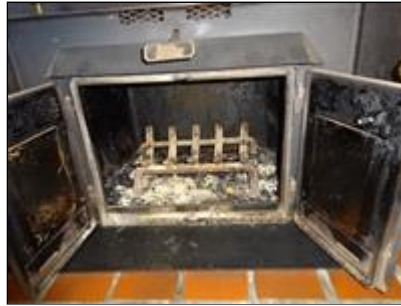
8.6 Picture 1

8.6 The insert has creosote build-up and needs to be cleaned . A home inspector is not capable of viewing all parts or interior surfaces of a chimney flue or insert,all areas cannot be seen, angles, soot and lack of lighting. The National Fire Protection Association recommends that fireplaces and chimneys should be inspected and cleaned by a professional chimney sweep or fireplace technician prior to operation when a home is sold for safety.

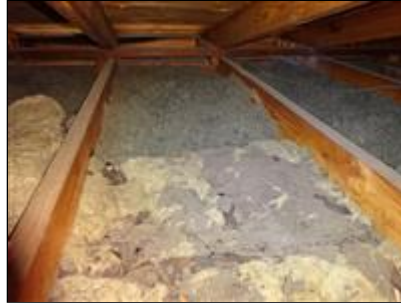
9.0 Picture 1

9.0 Insulation is old and has settled; less than four inches in thickness remains in attic. Heat loss can occur more on this home than one that is properly insulated.

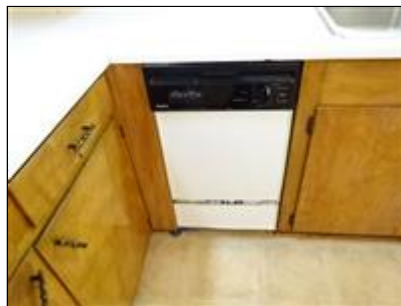
10.0 Picture 1

10.0 The dishwasher did not operate when tested. I recommend repair as necessary.

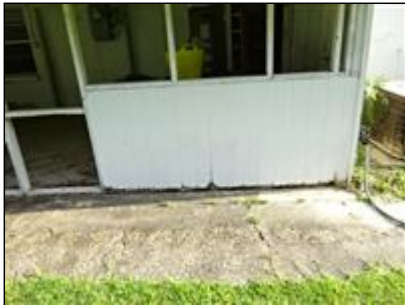
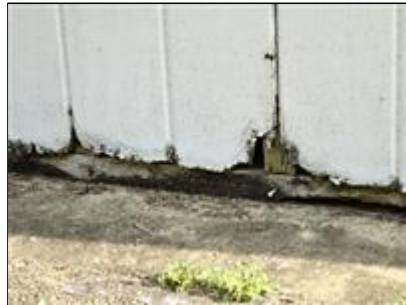
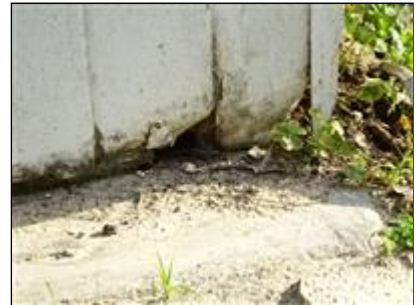
(2) Moisture damage at multiple areas around the screened porch.

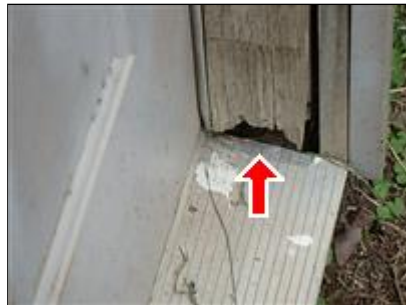
1.2 Picture 1

Moisture damage at the rear entrance door.

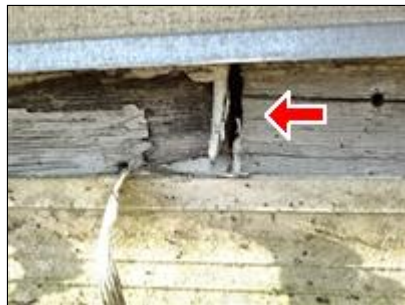
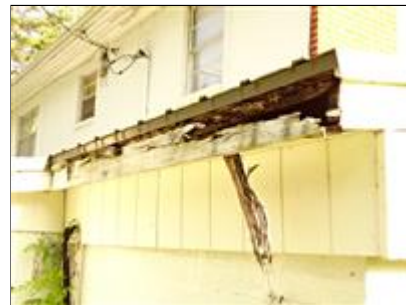
Moisture damage is occurring at multiple areas around the exterior.

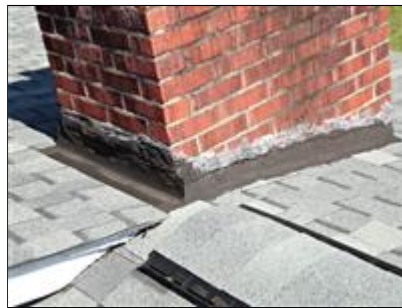
2.1 Picture 1

The chimney base has been tarred instead of flashed. This area will need periodical maintenance.

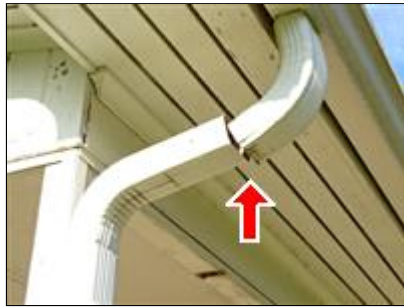
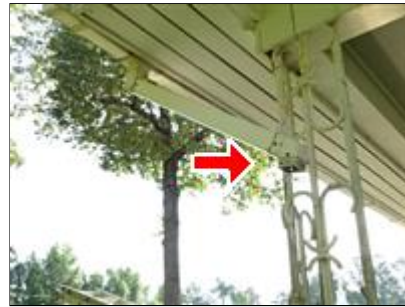
(1) Downspouts not connected properly and missing in areas.

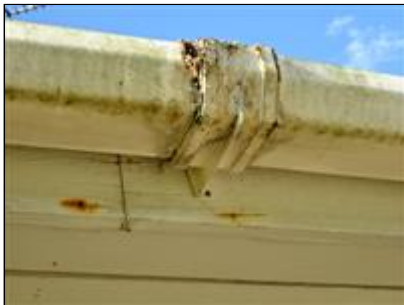
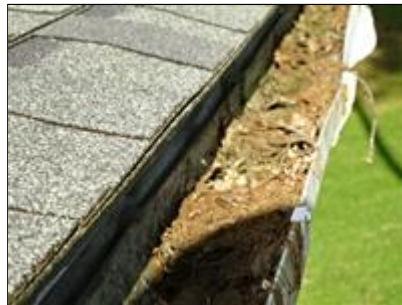
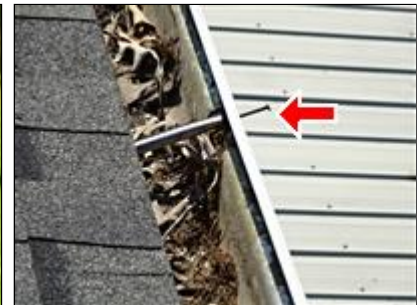
(2) The gutters are in poor condition and need cleaning of debris. Gutters that drain poorly or clogged can lead to many costly problems such as deterioration of fascia, soffit or roof edge, the debris in gutters can also conceal damage, rust, deterioration or leaks that are not visible until cleaned.

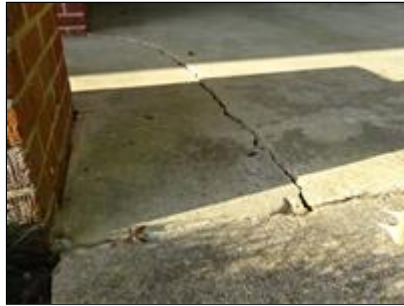
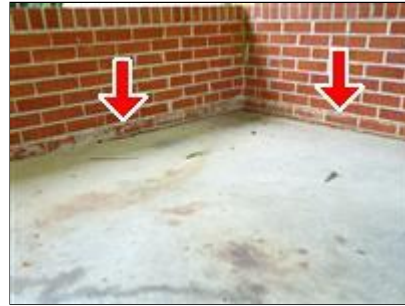
The carport slab is cracked and settled approximately 3-4 inches at the rear. I would recommend a qualified licensed contractor evaluate further and correct as needed.

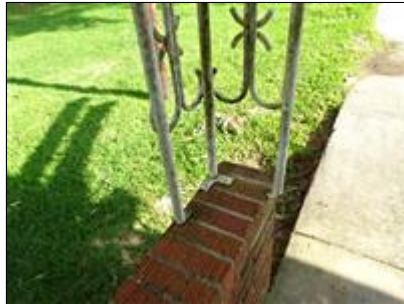
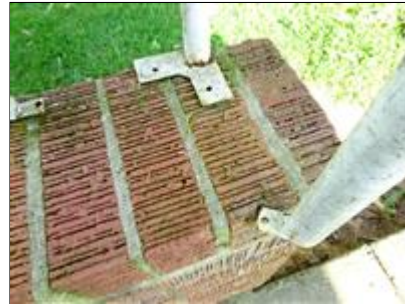
One or more metal support post are not secured properly.

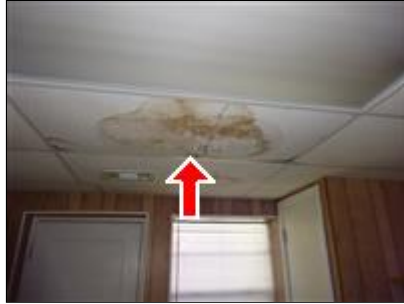
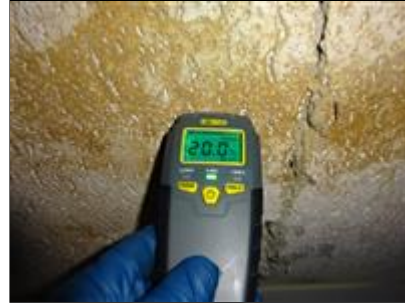
Moisture stains and elevated moisture indicating what appears to be a plumbing leak at the downstairs bedroom. Recommend a qualified licensed plumber and contractor correct as needed.

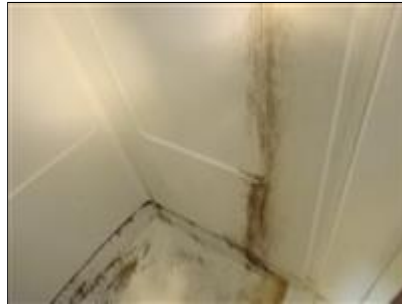
4.1 Picture 1

Signs of fungi growth is present at the downstairs bath. We did not inspect, test or determine if this growth is or is not a health hazard. It is beyond the scope of this inspection to identify what substance or organism this is. The underlying cause is moisture. I recommend you contact a mold inspector or expert for investigation or correction if needed.

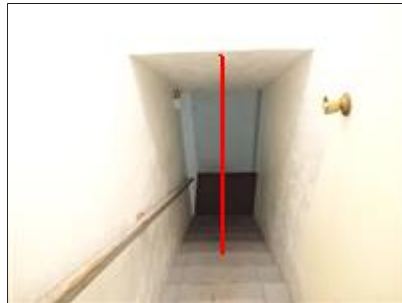
4.3 Picture 1

The ceiling height over the stairs was too low (75 inches) and poses a safety hazard, especially for tall people. Ceilings over stairs should be at least 6 feet 8 inches high. At a minimum, be aware of this hazard, especially when guests who are not familiar with the stairs are present.

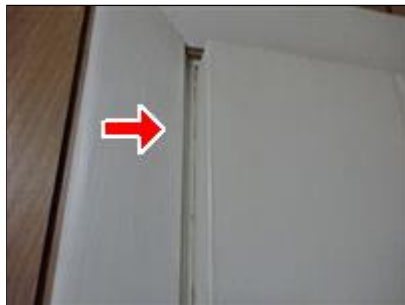
4.5 Picture 1

Several doors will not close throughout the home.

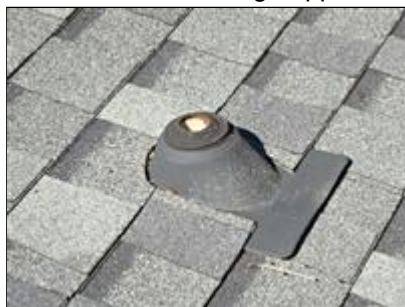
6.0 Picture 1

(1) The plumbing vent pipe should extend above the boot flange approximately 6 inches.

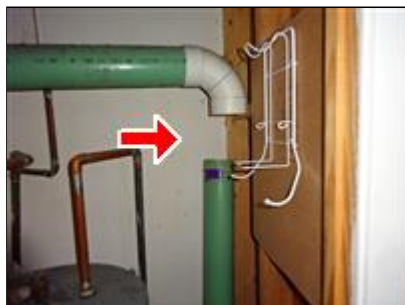
6.0 Picture 2

(2) Vent pipe is not connected at the downstairs closet.

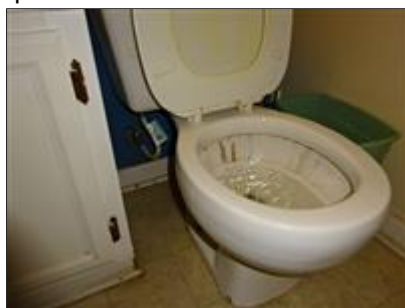
6.0 Picture 3

(3) The toilet in the downstairs bath is inoperable.

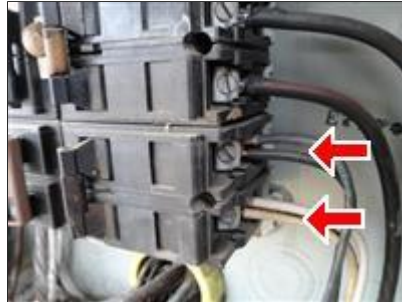
7.1 Picture 1

Double tapping at the exterior panel. Why it's a problem: If the circuit breaker isn't designed to hold two wires, the wires could come loose at some point in the future, even if they feel very tight today. Loose wires can lead to overheating, arcing, and possibly a fire.

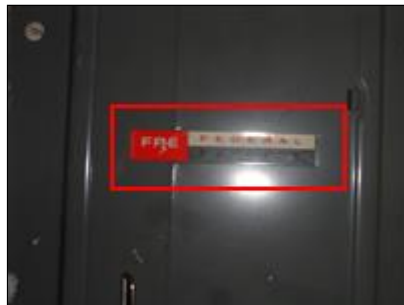
7.2 Picture 1

(1) You have a Federal Pacific panel and there is a possibility that the circuit breakers may not trip when shorted possibly causing an electrical hazard. Opinions by licensed electrical contractors on this panel varies between safe and unsafe. I recommend that a qualified licensed electrician evaluate the panel further and repair or replace as needed.

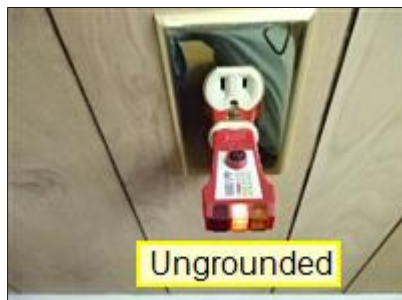
7.2 Picture 3

(2) "Common defect found in many older homes" The house has 3-prong receptacles and most all of them are ungrounded. The lack of a grounding conductor will limit the use of certain appliances that require a ground.. Although a ground isn't required of 2-prong receptacles, if the receptacle is 3-prong and ungrounded, it gives a false sense of safety. Grounding of all 3 prong receptacles or protection with ground fault circuit interrupters (GFCI's) is recommended for safety reasons.

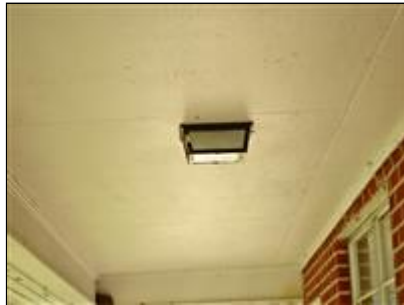
7.3 Picture 1

(1) Some light fixtures at the exterior of the home did not respond to the switch. The bulbs may be burned out or a problem may exist with the fixtures, wiring, or switches. If after the bulbs are replaced and these lights still fail to respond to the switch I recommend a licensed electrician evaluate further and repair or replace as necessary.

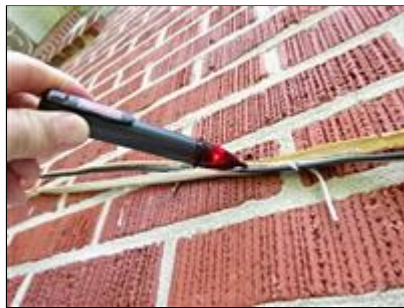
7.3 Picture 3

(2) Exposed, damaged wiring at the right side of the home and at the AC condenser. Today's common building standards generally require electric wires to be protected, which typically (but not in all cases) means enclosed, or encased in conduit or a raceway, particularly if below seven feet or in an area where it can easily be damaged for safety.

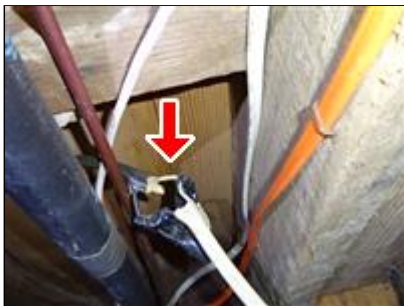
7.3 Picture 5 Storage room

(3) Hot, improper/open splices at the storage room and attic. All splices and loose wire ends should be installed inside a box with a cover plate to contain any sparks that could be created "if" there were ever a problem with the connections and to prevent electrical shock.

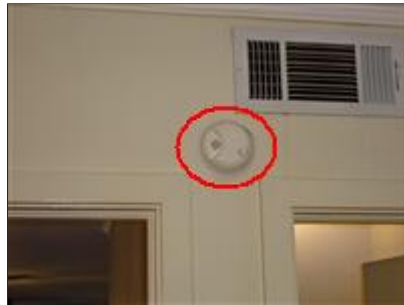
7.8 Picture 1

The smoke detectors were inoperable. It is recommended at least one smoke detector be located on each level of the home and all bedrooms should have one smoke detector installed for safety

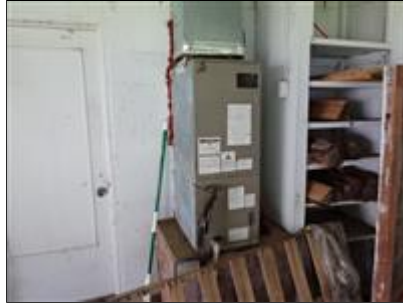
8.0 Picture 1

(1) The downstairs unit is over 20 years old and did not function at the time of the inspection. Recommend a qualified HVAC technician repair or replace as needed. A replacement is likely.

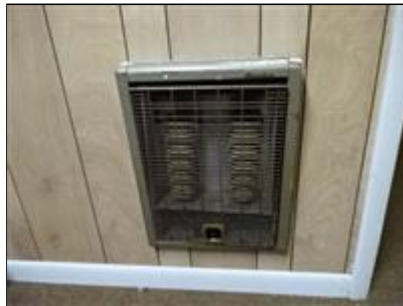
8.0 Picture 2

(2) The old wall heaters are inoperable.

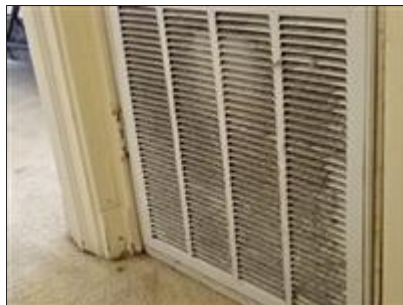
8.3 Picture 1

The disposable filter is dirty. As a result unfiltered air will flow through the system. Equipment life and the indoor air quality may be reduced. Recommend that filters be cleaned or changed once a month during the heating and cooling seasons.

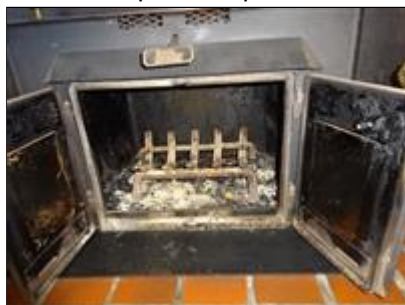
8.6 Picture 1

The insert has creosote build-up and needs to be cleaned . A home inspector is not capable of viewing all parts or interior surfaces of a chimney flue or insert,all areas cannot be seen, angles, soot and lack of lighting. The National Fire Protection Association recommends that fireplaces and chimneys should be inspected and cleaned by a professional chimney sweep or fireplace technician prior to operation when a home is sold for safety.

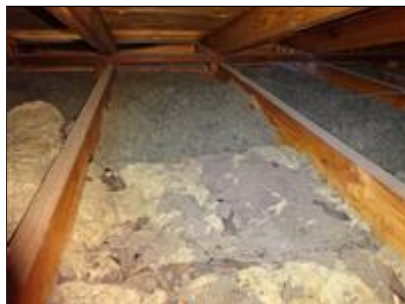
9.0 Picture 1

Insulation is old and has settled; less than four inches in thickness remains in attic. Heat loss can occur more on this home than one that is properly insulated.

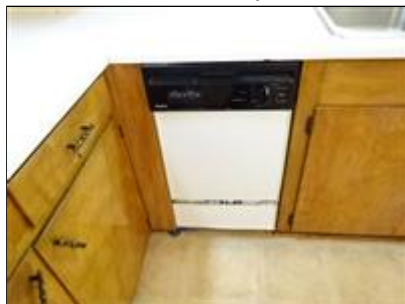
10.0 Picture 1

The dishwasher did not operate when tested. I recommend repair as necessary.
